THE  
QUEBEC LAND SLIDE  
OF 1889.

C. BAILLAIRGE, M. CAN. SOC. C. E.

**THE QUEBEC LAND SLIDE OF SEPTEMBER 19, 1889.**

By CHAS. BAILLAIRGÉ, M. Can. Soc. C. E.

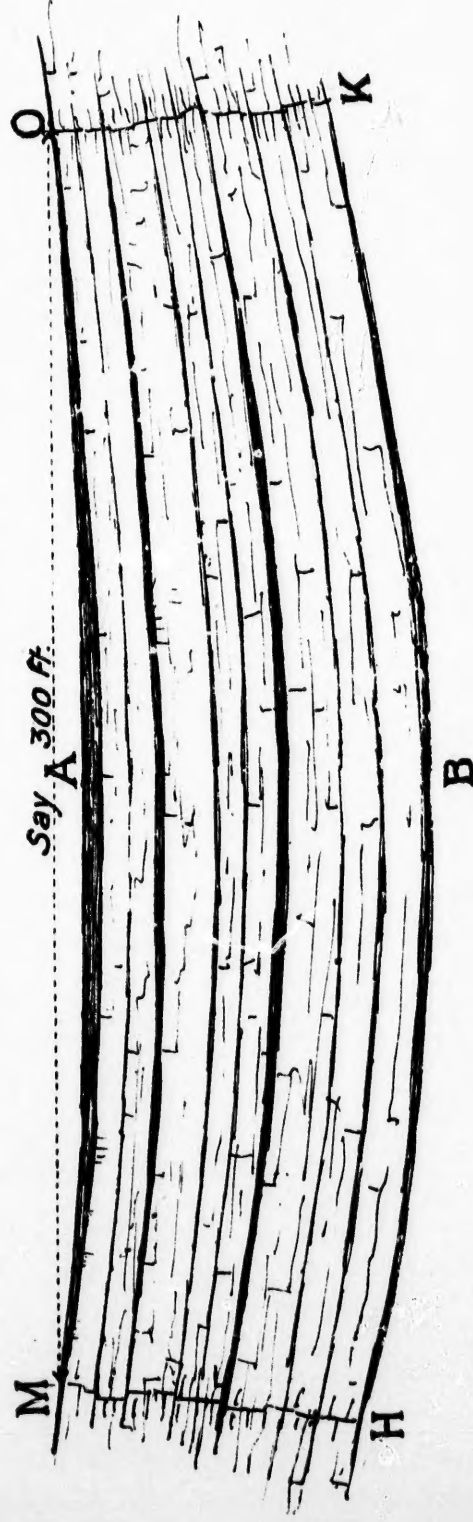
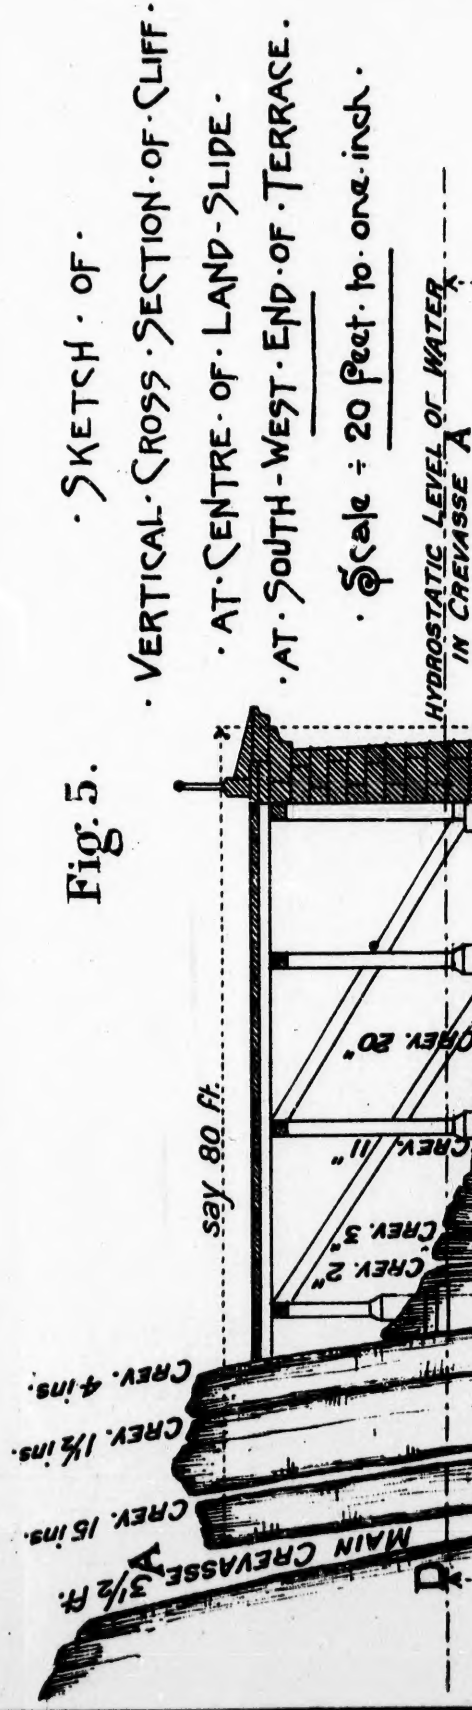
· VERTICAL · CROSS · SECTION · OF · CLIFF ·

Referring to Plate VII at *A* on plan and at *A D C* on section,

is the present crevasse or fissure into which the water poured and has been pouring for maybe 30 years past, or ever since the drain, which ran north-eastward down the cliff towards the river, ceased to be operative, as evidenced by the author from the fact that from its outcrop half way down the cliff no water had been running for fully that number of years.

The author had the crevasse *A* gone into and sounded to a depth of more than 70 ft. below the surface, or to *N* on section; and as at that depth there was still the breadth of a man's body, it was made evident by "similar triangles" that the total depth of the crack was 125 ft. below *A* and 100 ft. at *D*—the general level of the rock and earth beneath the terrace flooring—and to which level *D* any water filling the crevasse from *C* could rise without any possible issue below said level *D*.

Coming now to the actual solution of the problem as to the hydrostatic power of the water to bring about the accident, the following are the data: The crevasse at *A* extends and can be followed for 150 ft. or more from *A* to *O* on plan, where it thins out to nothing. In the opposite direction, or from *A* to *M*, it is also assumed to close or come to naught at a like distance of 150 ft., together 300 ft., and this assumption is based on the fact that the crack was gone into in that direction to say 70 ft. from *A* towards *M*, and its breadth at that point such—that of a man's body—as to warrant the assumption.

It has already been said that the depth of crevasse is from *D* to *C* on section 100 ft. At *A*, the outcrop, the amplitude of crack is now  $3\frac{1}{2}$  ft. and at *D* 3 ft.; but before the accident occurred it was but  $2\frac{1}{2}$  ft. at *D* or 3 ft. at *A*, the crevasse having opened by some 6 inches at its centre of position or at *A* on plan and section at the time of the catastrophe. Now,  $2\frac{1}{2}$  ft. at *D* and naught at *C* gives 15 inches at *N*. Again, these 15 inches at *N* or half way down beneath *A* on plan, and as the crack dies out at *M* and *O*, give a general average of  $7\frac{1}{2}$  inches for the breadth or width or amplitude of the crevasse.

The face of the crevasse is, as already inferred, 300 and 100 ft., or 30,000 square ft., and the average breadth being  $7\frac{1}{2}$  inches, gives 17,500 cubic feet capacity, or say from 15,000 to 20,000 cubic ft. The 30,000 cubic ft. of rainfall, which during the 12 hours, or from 8 a.m. to 8 p.m. of the 19th Sept., 1889, precipitated itself through the side aperture in the drain, and which is in about the same vertical plane as *A B* on plan and section, found its way into this crevasse and filled it up to *D* (the spare 10,000 to 12,000 being more than abundantly sufficient to allow for any leakage out at the bottom or sides as it entered at the top), exercising therefore on its opposite faces a separating effort of not less than 6,250 lbs. per square ft. at *C*, 4,166 $\frac{2}{3}$  lbs. at the centre of pressure, or  $\frac{1}{3}$  up from *C*, 3,125 lbs. at the centre of gravity of the figure, or half way up, the figure being a parallelogram, and a total thrust on the whole surface of 46,875 tons.

The conclusion therefore is that the 46,875 tons water pressure could and did cause the still existing portion of the cliff *B C* to move forward at *B* or along *B E*, where it came in contact with the portion *E F* and caused it to fall forward.

Now to save the Terrace and avoid the necessity of shifting the roadway, the author proposes that a retaining wall be built some 300 ft. in length, 40 ft. high, 20 ft. thick at bottom and 15 ft. at top, battering back 5 ft. in the 40 or 1 in 8, and with layers perpendicular to the batter or dipping towards the cliff, so that any effort to thrust the wall forward must be increased by the necessity to lift the wall along an inclined plane of 1 in 8, the rock foundation having to be cut or stepped to this slope for the purpose.

The outlying debris which now cover the roadway to a depth of say 20 ft., and render access to our drainage and water mains an almost hopeless and very expensive task, would be lifted and swung into the space between the cliff and wall, thus clearing and relieving the roadway and leaving some 10,000 yards of stone to be brought from Cap Rouge or elsewhere and dumped down from the edge of the terrace to complete a slope reaching high enough to prevent future slides and accidents.

One or more drainage tunnels as proposed by Mr. Cunningham would further eliminate any danger of additional pressure by water or frost.
